7/17/2023 - Updated information regarding SST Tools

Safety Recall 5823D – 2022-2023 CX-30 and 2023 CX-50 Brake Pedal Travel May Increase

REPAIR OUTLINE

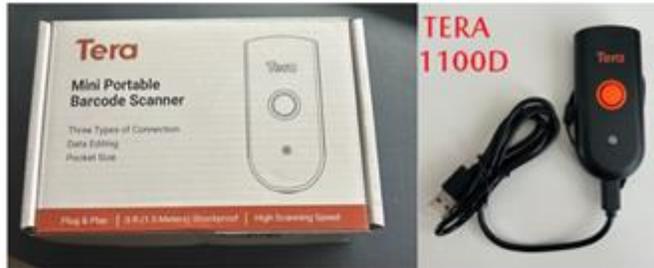
Use the Scan Tool with the black cable only, please do not use the “Bluetooth” dongle in the SST Scan Tool box as it does not work (red X in the box photo).

EY-015P. ONLY USE THE USB CABLE. DO NOT USE THE USB DONGLE TO SCAN

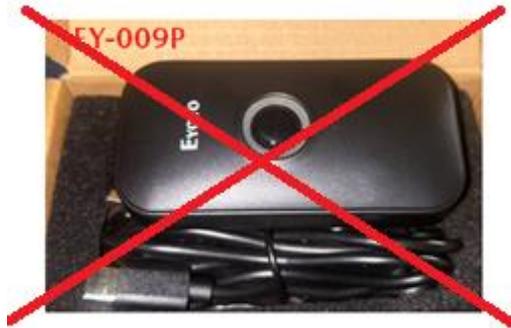
If you received this SST Tool below, Model EY-009P fill out the Dealer Recall Help Form located on [OneMazda](#) right away and **do not use** this tool. Dealers have reported problems with this tool but only approximately 20 of this specific tool were sent to dealers. The other 2 tools are working correctly.

1. Please send a photo of your EY-009P tool to Dealer Recall Help
2. We will ship you a new working Tera 1100D USB SST tool AND a UPS label to return the EY-009P tool
3. Otherwise, if you have trouble with the other 2 SST Tools, please fill out Dealer Recall Help located on [OneMazda](#).

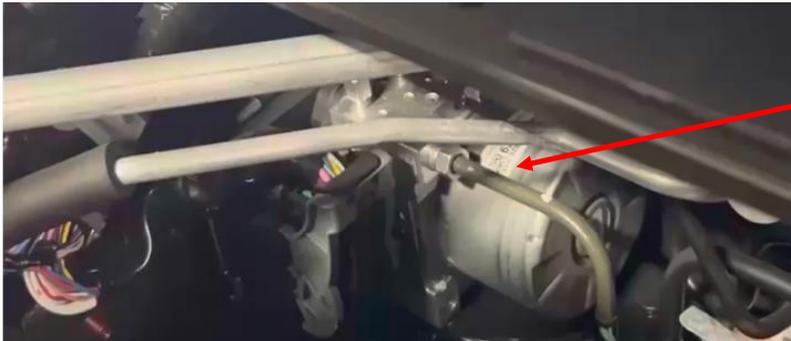
3. With the hood raised, place the Laptop on the Engine Cover with the USB Scan Tool Connected. Locate the ABS Unit (DSC HCU) under the rear LH side engine bay. You will need to scan the QR Code on the ABS Unit.

4. Place the cursor in the “ABS HCU SERIAL NUMBER” Field. Using the Barcode Scanner, Press and Hold the Orange button and scan the QR Code on the ABS Unit (DSC HCU). [Click Here to see a VIDEO on how to scan the QR Code “Video to Scan QR Code.”](#) This VIDEO is also available in MGSS under the 5823D Documents.
